R22 SERVICE BULLETIN SB-116

R44 SERVICE BULLETIN SB-103

R66 SERVICE BULLETIN SB-36

SUBJECT: Main Rotor Blade Tip Plate Permanent Removal & Sealant Application

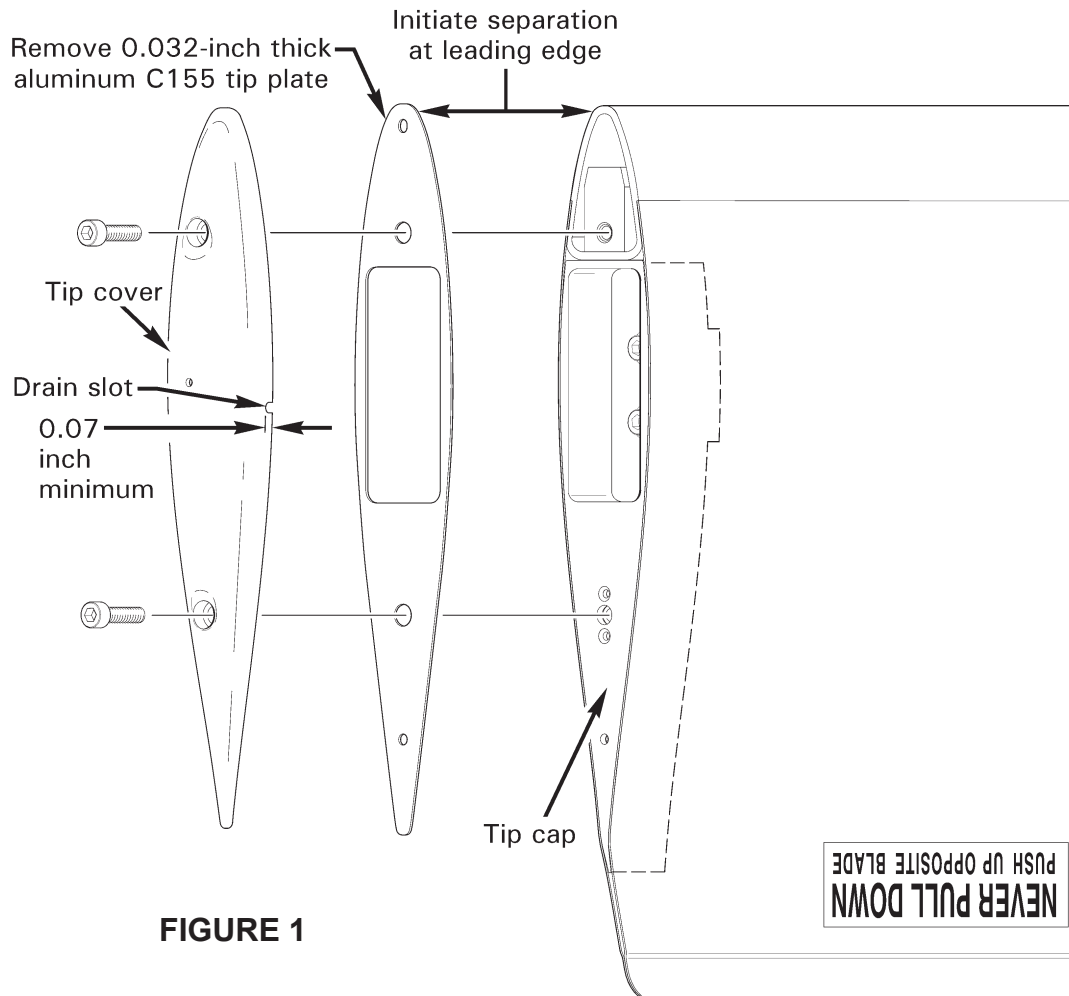
BACKGROUND: This bulletin requires permanent removal of C155 tip plates from specified main rotor blades and application of polysulfide sealant for improved corrosion resistance.

1. Refer to Figure 1. Position main rotor blade to allow tip access and apply rotor brake. Support blade in level (spanwise) position with cushioned stand.
2. Remove tip cover from blade. If tip plate has previously been removed, proceed to step 4.
3. Initiate separation of tip plate from spar using mallet and a razor blade; hold razor parallel to plate. Peel off plate by pulling with pliers. If tip plate is removed from only one of an installed pair of blades, weigh removed tip plate and add equal amount balance weight to tip.

- Refer to Figure 1. Visually inspect tip cover for corrosion. Remove any corrosion from tip cover clamping surface, and maintain surface flatness, by hand-sanding tip cover on 220-grit aluminum-oxide abrasive paper on a flat plate. Minimum allowable height of cover's drain slot after rework is 0.07 inch. Clean bare metal area with acetone, prime with two coats of epoxy primer (chromated epoxy preferred), and allow to cure.
- On blade tip, prime bare metal with two coats of epoxy primer (chromated epoxy preferred), and allow to cure.
- Install tip cover and special torque screws to 40 inch-pounds wet with A257-9 anti-seize.
- Apply topcoat to blade tip and tip cover within 2–48 hours of primer application. For best performance, allow topcoat to cure 48 hours before flight.
- Make appropriate maintenance record entries.
