R44 SERVICE LETTER SL-58

R66 SERVICE LETTER SL-20

DATE: 30 January 2017

SUBJECT: C258-5 Pitch Link Assembly

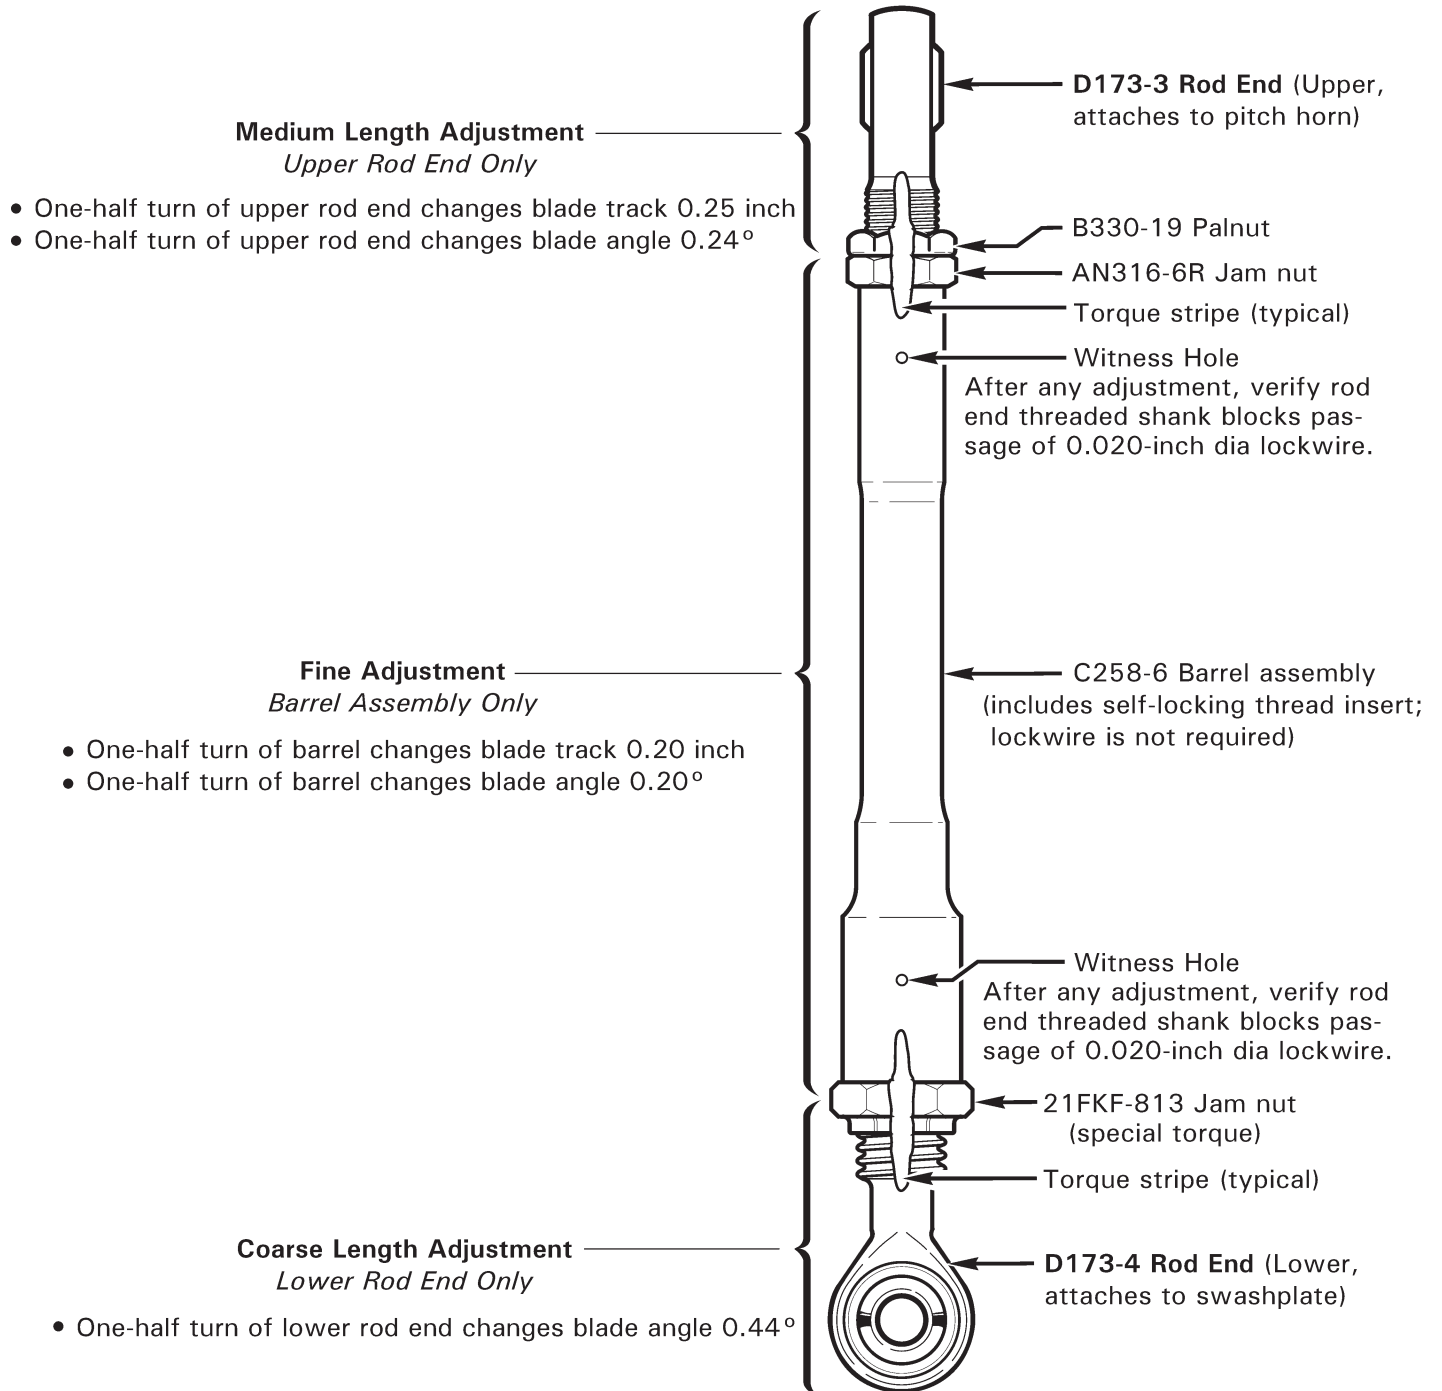
BACKGROUND: Part number C258-1 pitch link assembly, main rotor, is no longer available and is superseded by new part number C258-5 pitch link assembly. C258-5 link assembly features a separately replaceable lower rod end. This service letter provides instructions for adjustment of the new C258-5 assemblies.

1. C258-5 pitch link assembly directly replaces C258-1 pitch link assembly, and may be installed singly or in pairs; there is no weight change.
2. When replacing pitch link assembly or pitch link parts, keep overall length within plus/minus 0.005 inch of removed link prior to disassembly.

3. After pitch link installation or adjustment, verify both rod end threaded shanks block passage of 0.020 inch diameter lockwire at witness holes in barrel assembly.

4. Apply torque stripes for maximum preflight visibility after torquing nuts.
5. Due to a self-locking thread insert, lockwire is not required.
6. Similar to C258-1 pitch link assembly, blade tracking fine adjustment is accomplished by rotating barrel with rod ends remaining connected to pitch horn and swashplate; one full turn of barrel is equivalent to one-half turn of upper rod end.

7. Apply light coat of A257-2 or A257-22 oil to threads when replacing rod ends.
